# Manhole Inspection Summary

Manhole # S51EE\_005MH

Insp Date: **6/27/08 9:22 AM**

**Location** Address: **Kenwood**

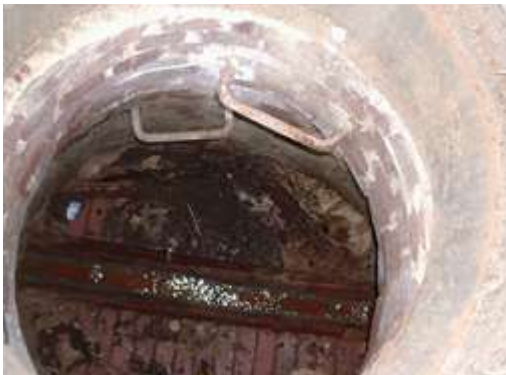
Defect 1

**Steps** Count: **2** Missing: **0** ☒ **Corroded**

corroded steps

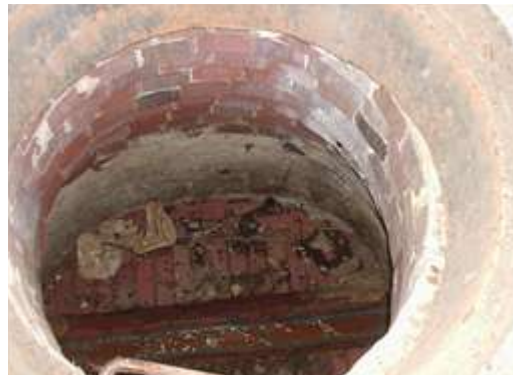
Defect 2

Infiltration: ☐ None ☒ **Joint** ☐ Cracks ☐ Mortar ☐ Roots ☐ Wall

Infiltration: ☐ None ☐ Joint ☐ Cracks ☐ Mortar ☐ Roots ☒ **Wall**

infiltration

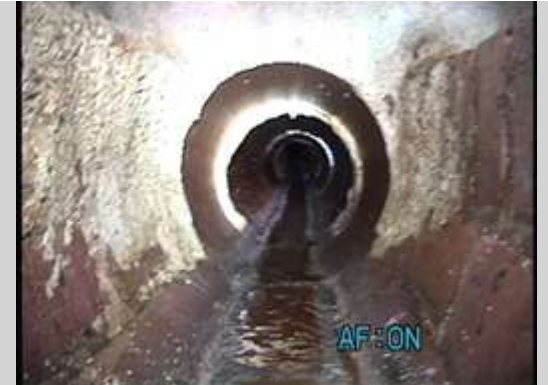
12 O'Clock Outflow

8 in. Circular Gravity Sewer  
Pipe Out @ 12 O'Clock

Pipe Height: **8.4** (in.) Rod and Bar (Angled)  
Pipe Material: **Clay** ☐ Pipe Lined  
Invert Depth: **5.90** (ft.) Flow Characteristics: **Fast**  
Deposits: ☒ None ☐ Mud ☐ Sludge ☐ Debris ☐ Grease  
Silt Depth: (in.) Deposits Extent:  
Infiltration: **None** Pipe Seal Cond: **Sound**

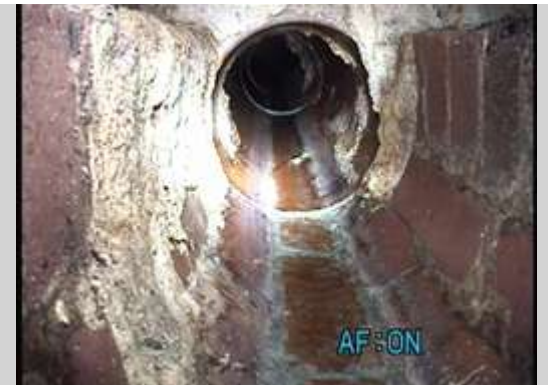
6 O'Clock Inflow

8 in. Circular Gravity Sewer  
Pipe In @ 6 O'Clock

Pipe Height: **8.4** (in.) Rod and Bar (Angled)  
Pipe Material: **Clay** ☐ Pipe Lined  
Invert Depth: **5.80** (ft.) Flow Characteristics: **Fast**  
Deposits: ☒ None ☐ Mud ☐ Sludge ☐ Debris ☐ Grease  
Silt Depth: (in.) Deposits Extent:  
Infiltration: **None** Pipe Seal Cond: **Sound**
